**CULTURAL RESOURCES SURVEY OF
THE SCE&G SALUDA DAM COMPLEX,
LEXINGTON COUNTY, SOUTH CAROLINA**

CULTURAL RESOURCES SURVEY OF THE SCE&G SALUDA DAM COMPLEX, LEXINGTON COUNTY, SOUTH CAROLINA

Prepared By:
Michael Trinkley, Ph.D.
and
Nicole Southerland

January 8, 2001
Revised September 7, 2001

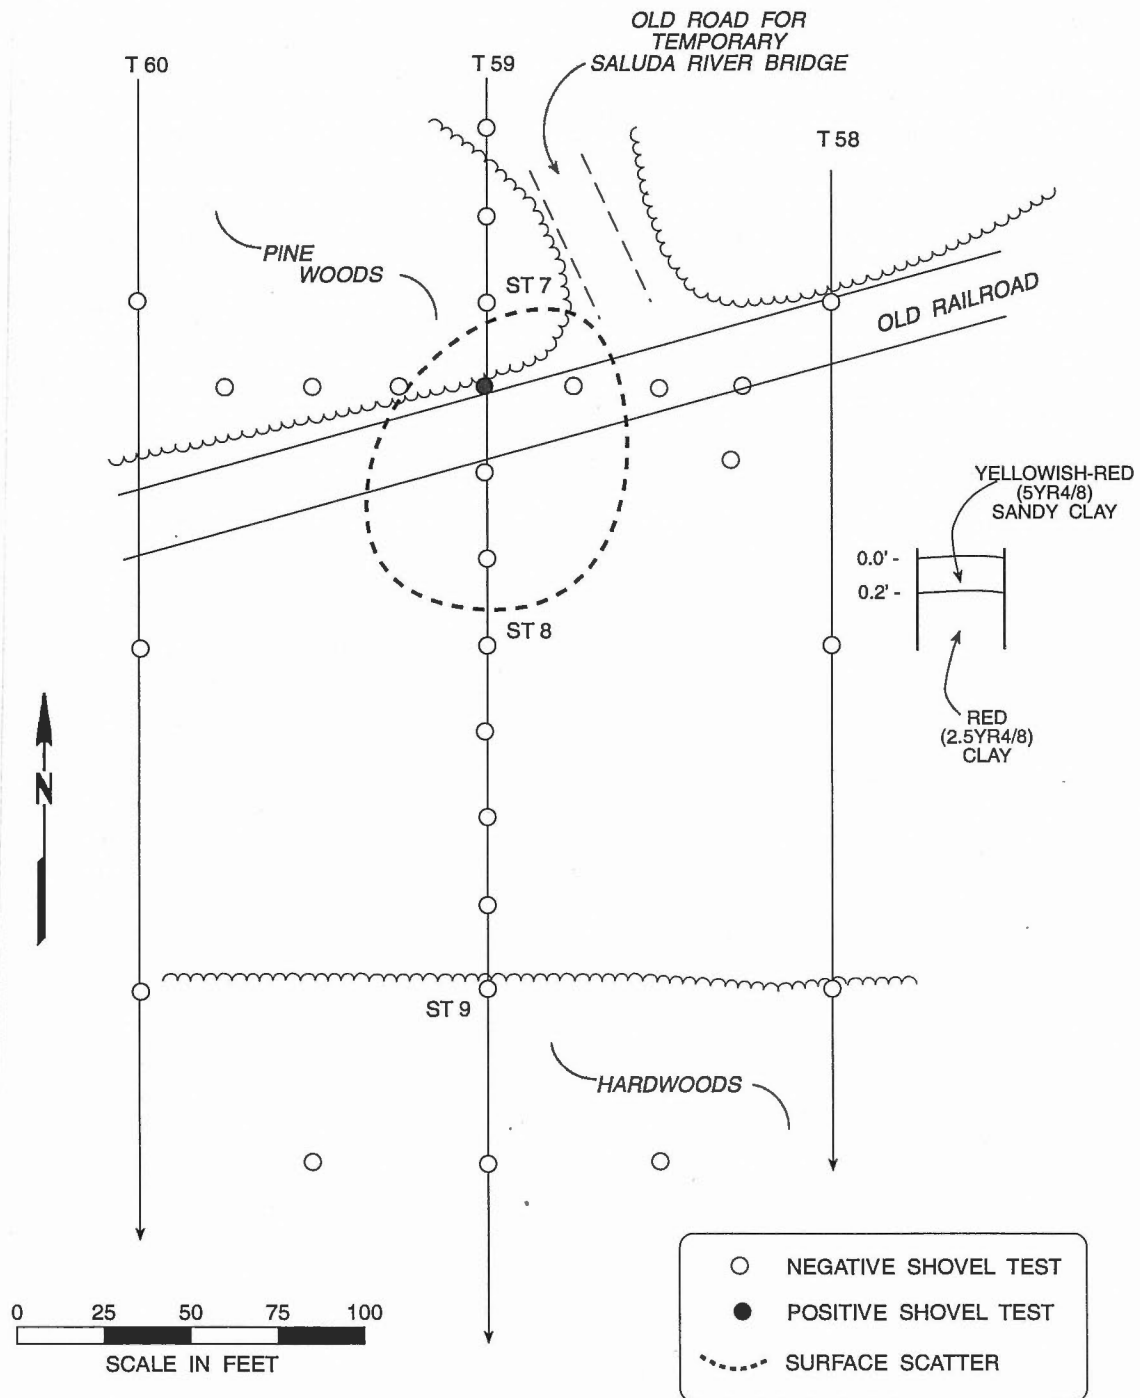
Figure 59. Plan and shovel test profile for 38LX436.

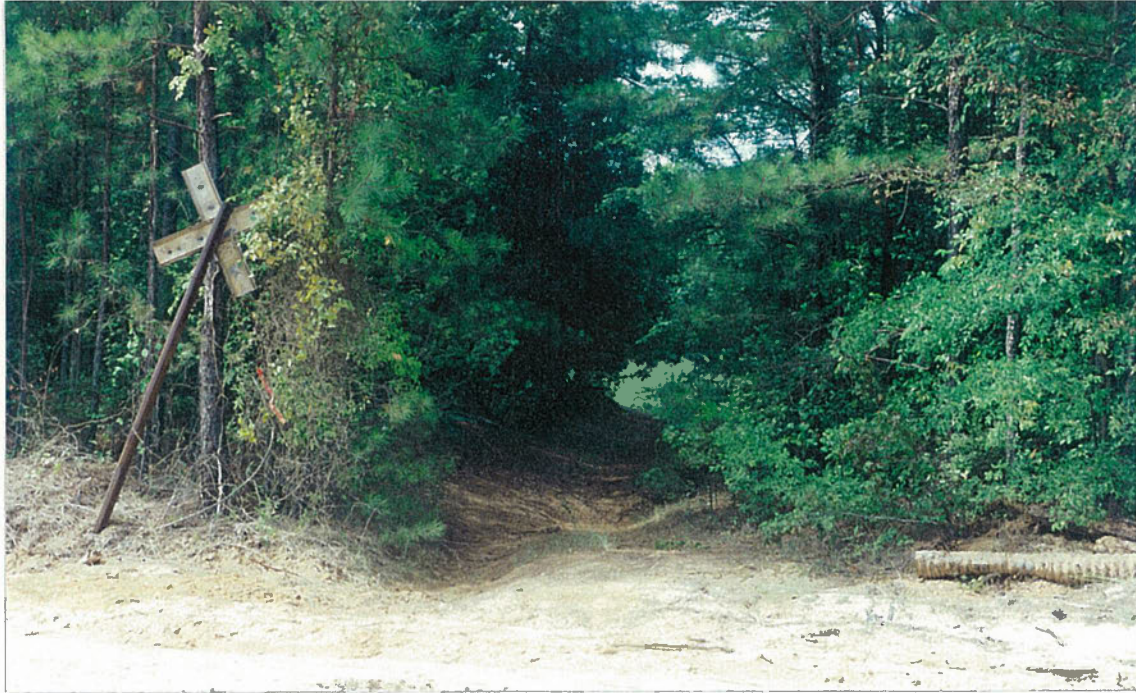
Figure 60. View of 38LX436 looking north. Note gullying in old road bed and extensive clearing and grubbing in the foreground.

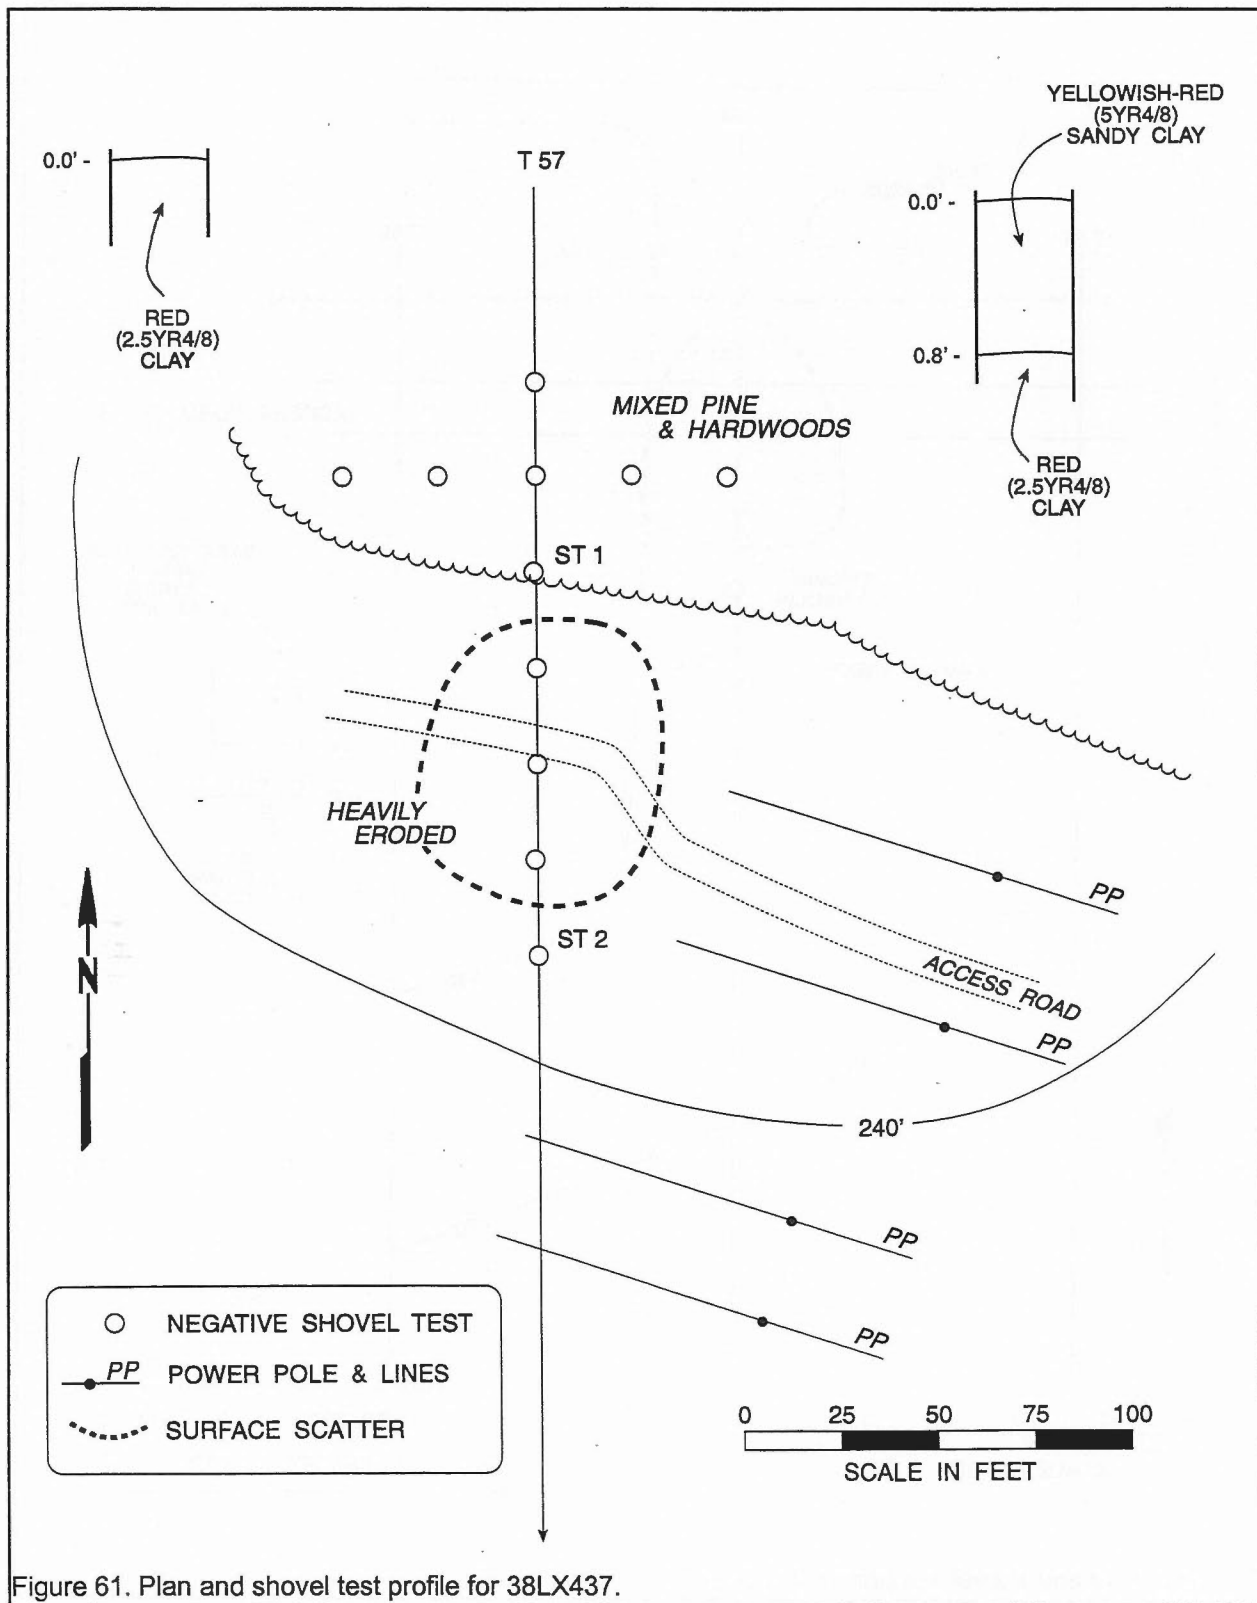
Figure 61. Plan and shovel test profile for 38LX437.

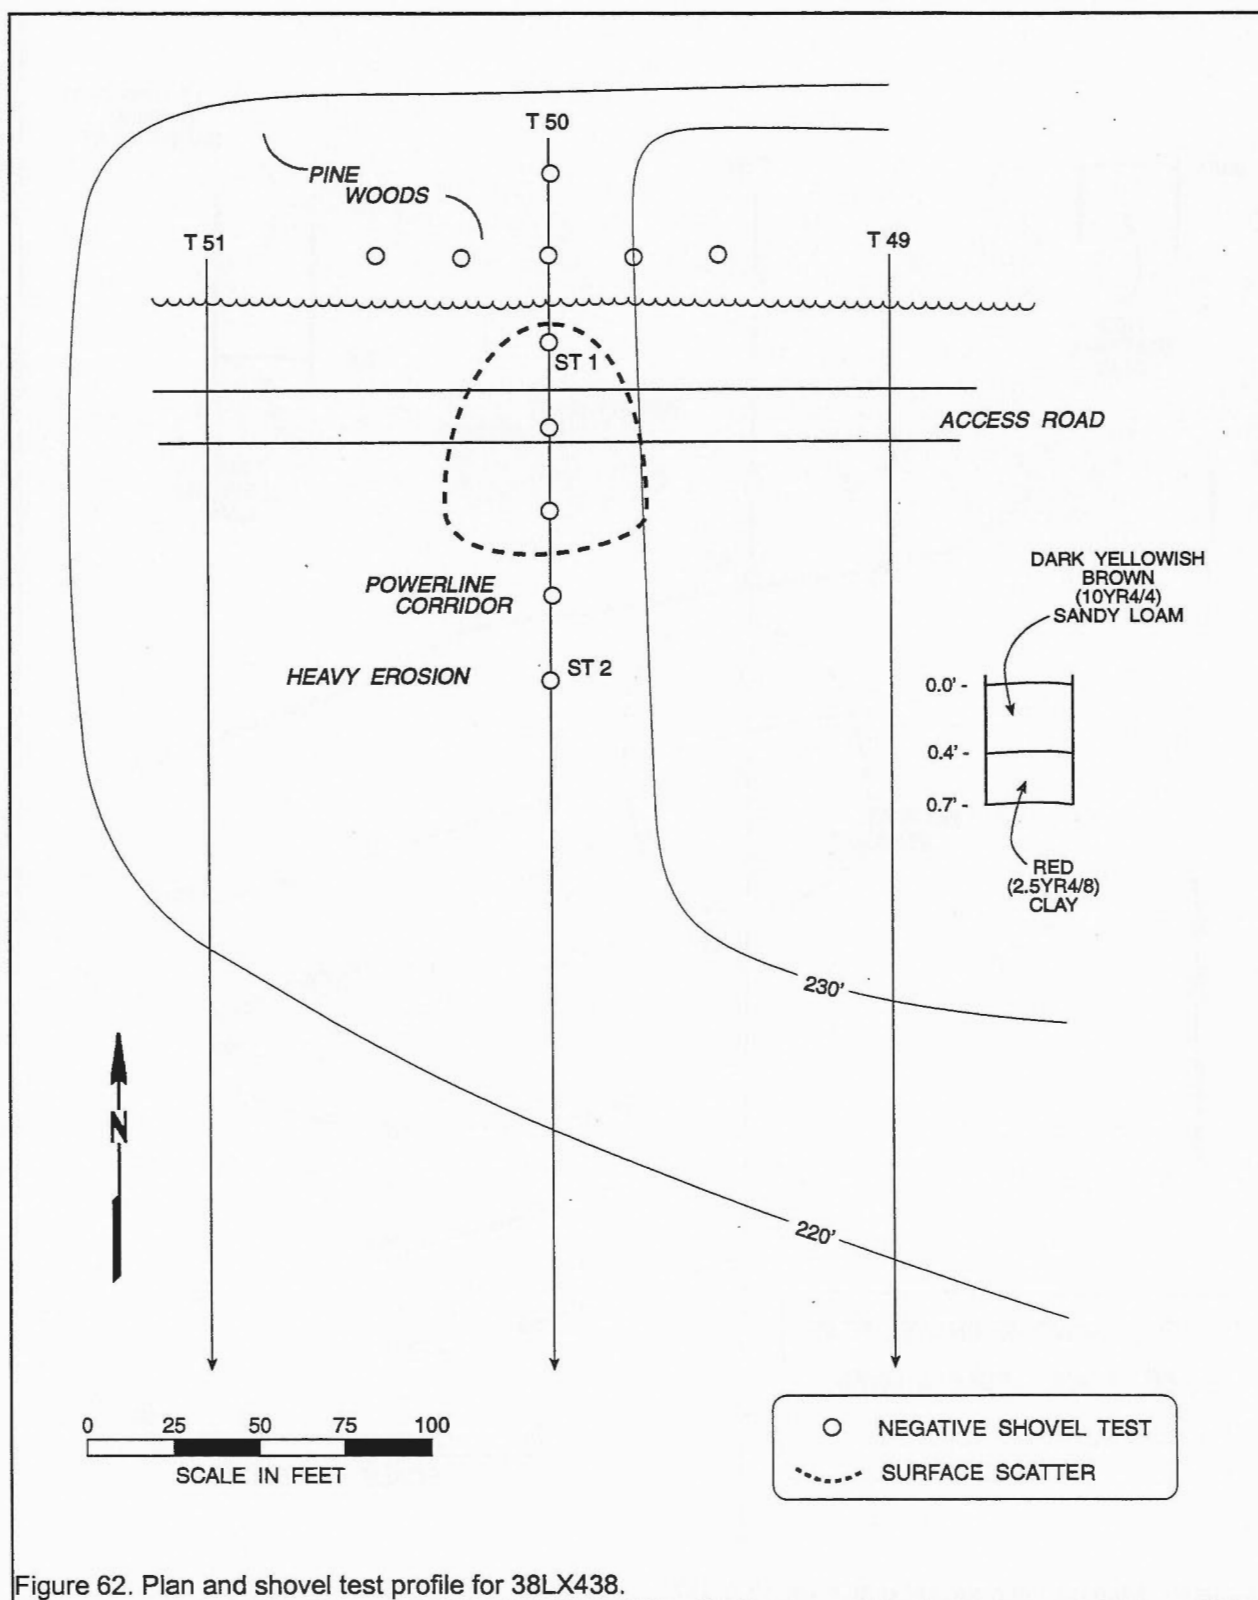
Figure 62. Plan and shovel test profile for 38LX438.

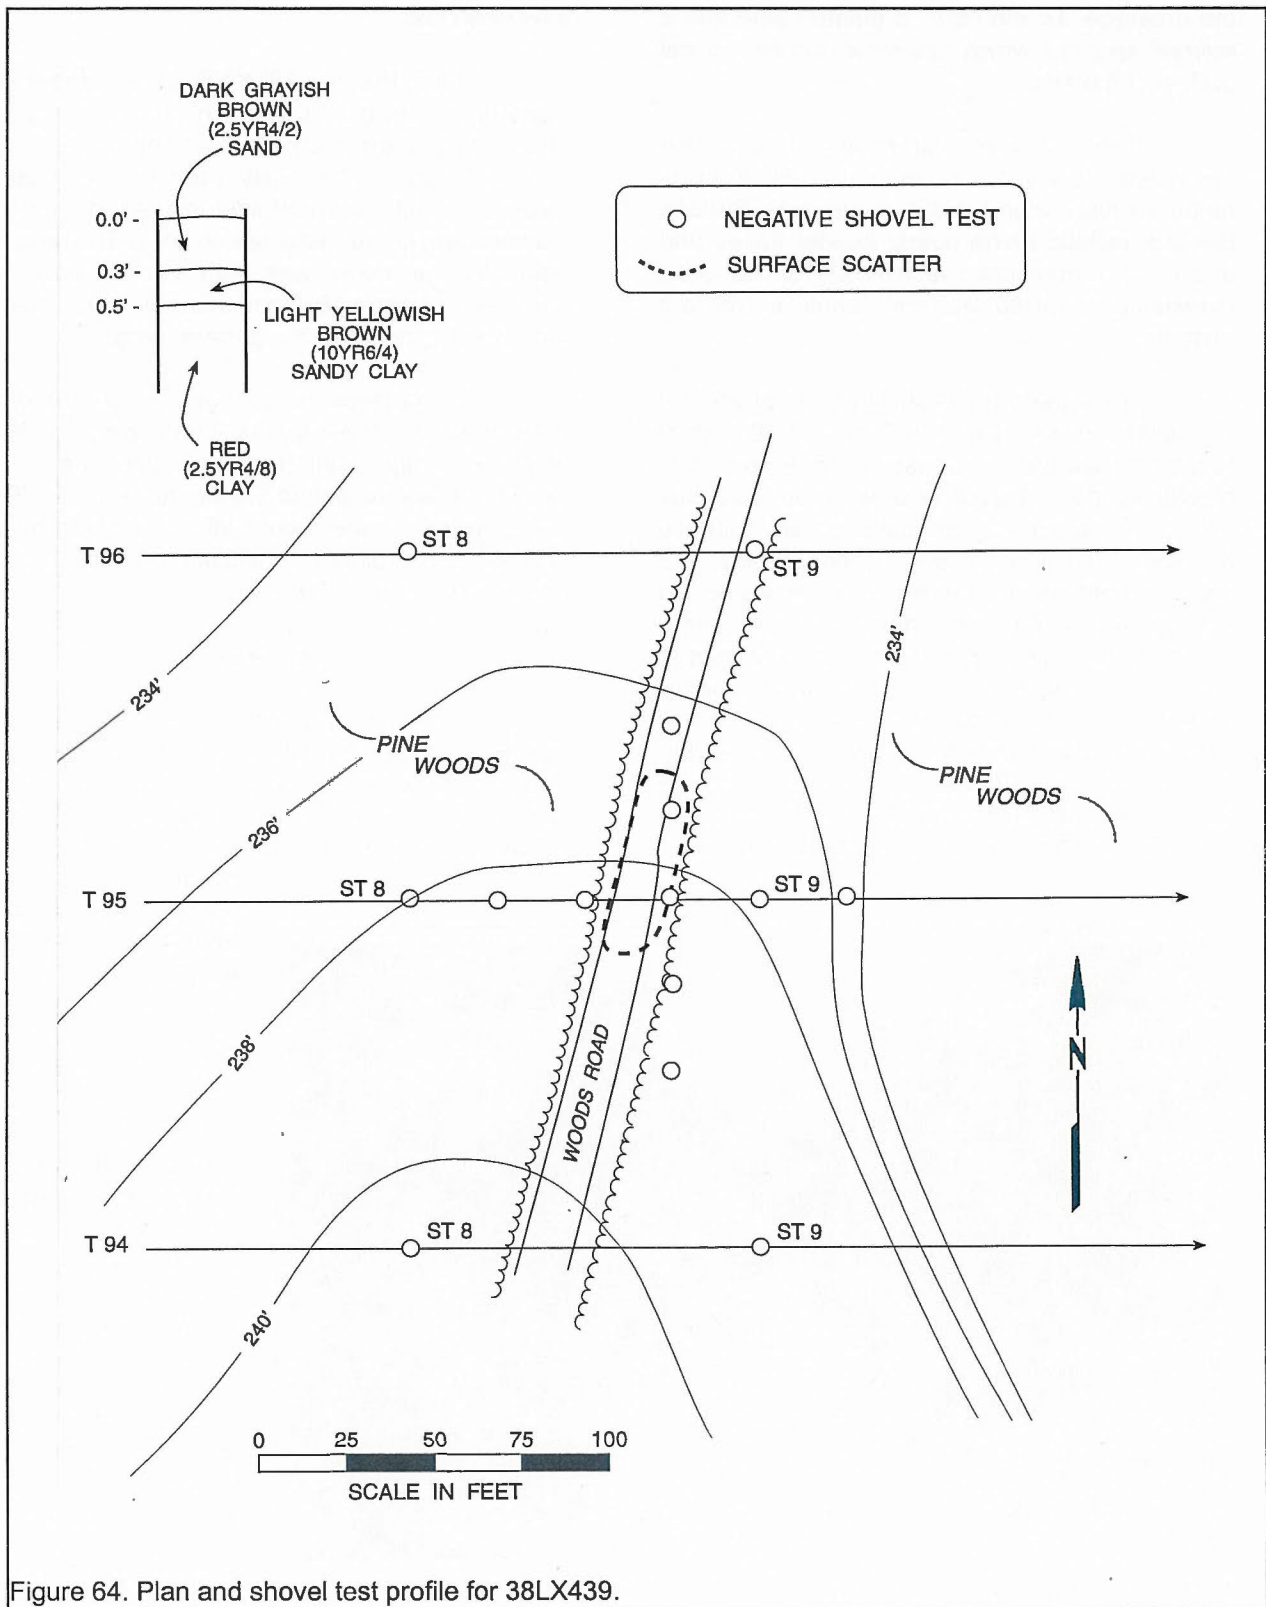
Figure 64. Plan and shovel test profile for 38LX439.

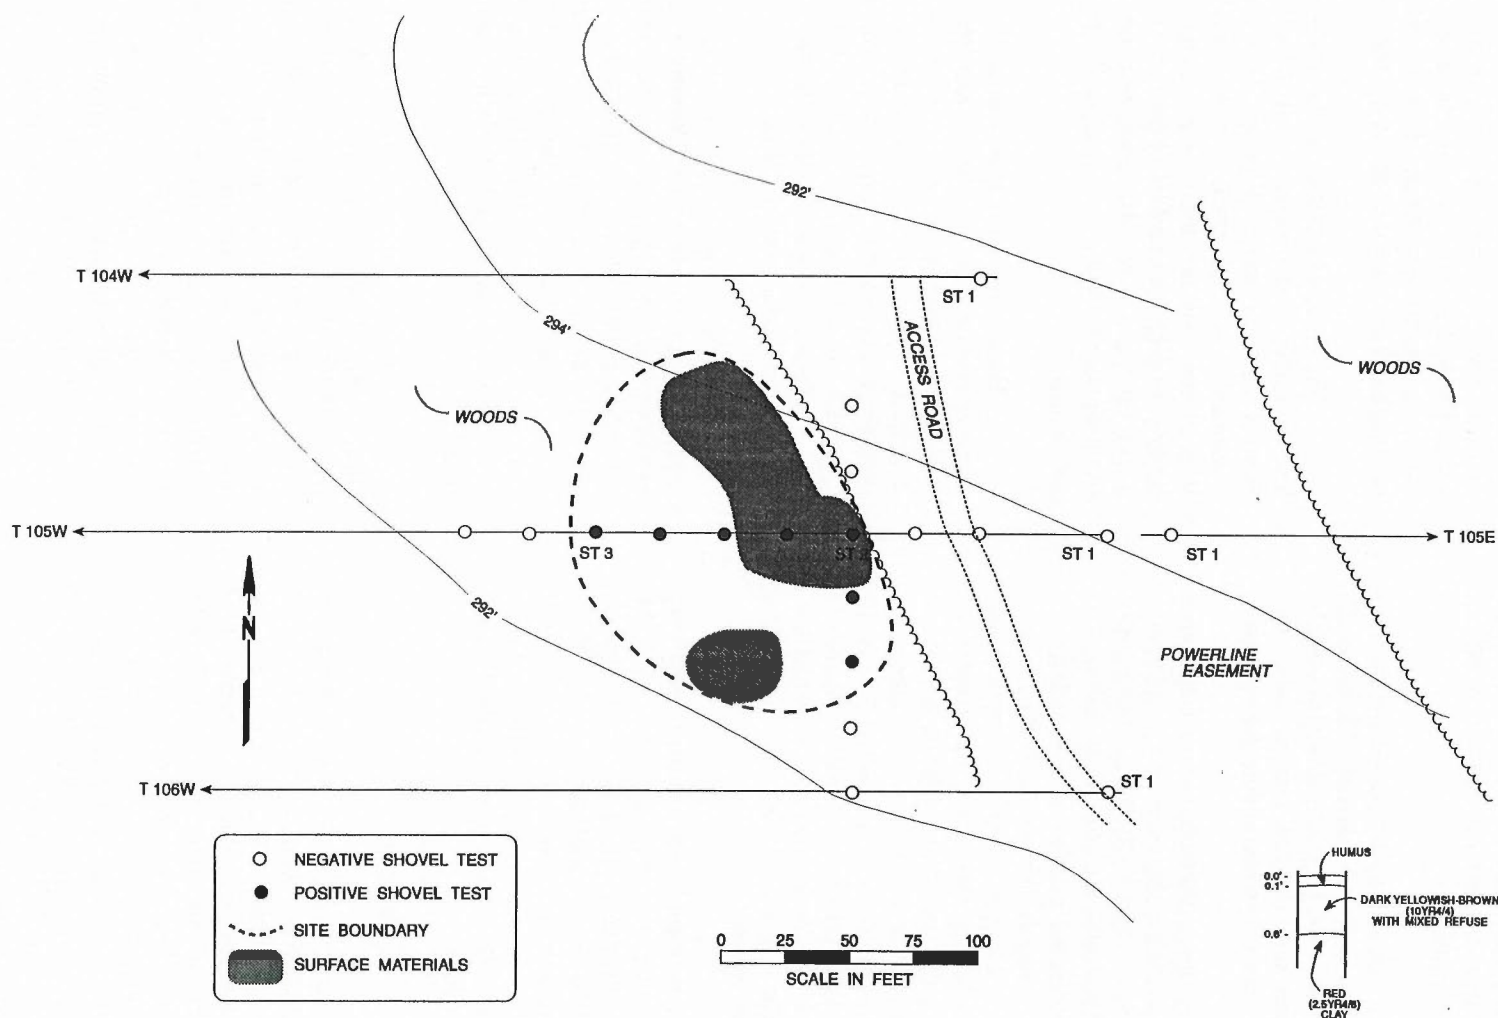
Figure 65. Plan and shovel test profile for 38LX440.

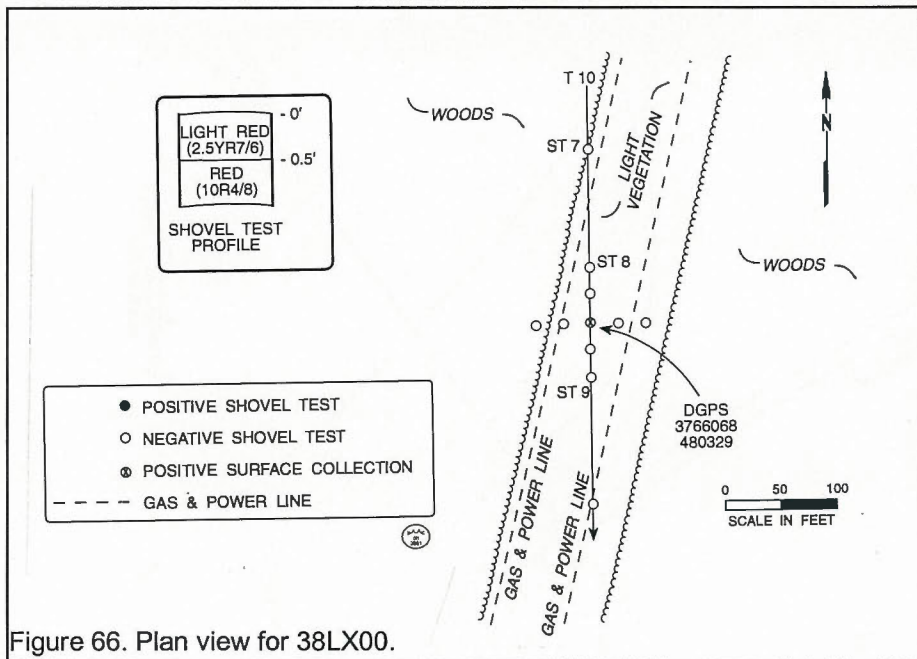
Figure 66. Plan view for 38LX00.

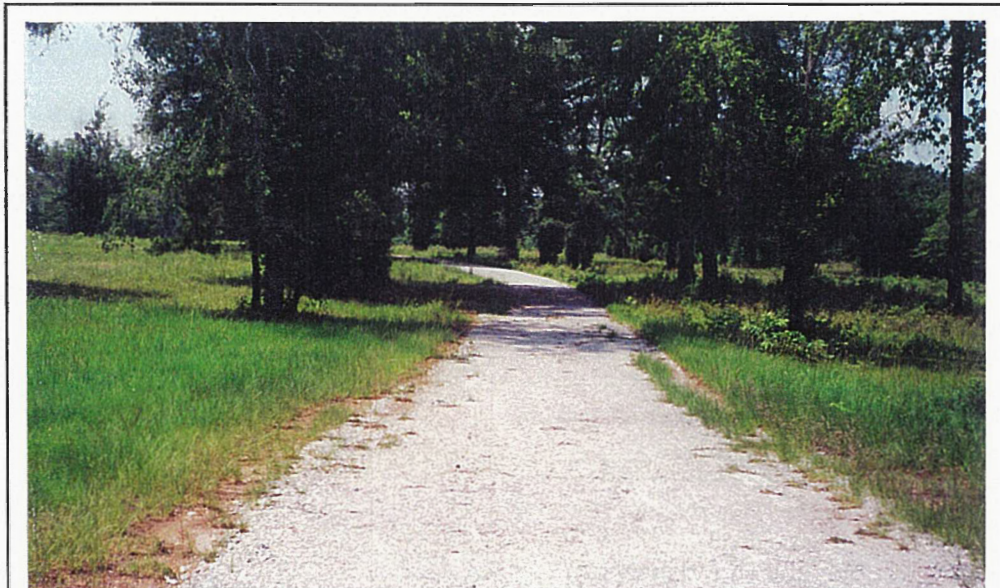
Figure 72. Road and level area of dam village, looking north.

Several surface features were encountered while performing the survey. Three 4.0 foot square concrete slabs with steel wire cables connected on top were found near the northern site boundary. These slabs were the base of the water tower (seen in Figure 19). Immediately under the water tower was a valve and an exposed pipe. Nearby is a brick valve pit measuring about 3 feet square, with three valve wheels. It is likely that these valves controlled the water flow to the various buildings. Between the slabs and valve pit was wood rubble which may have been the base

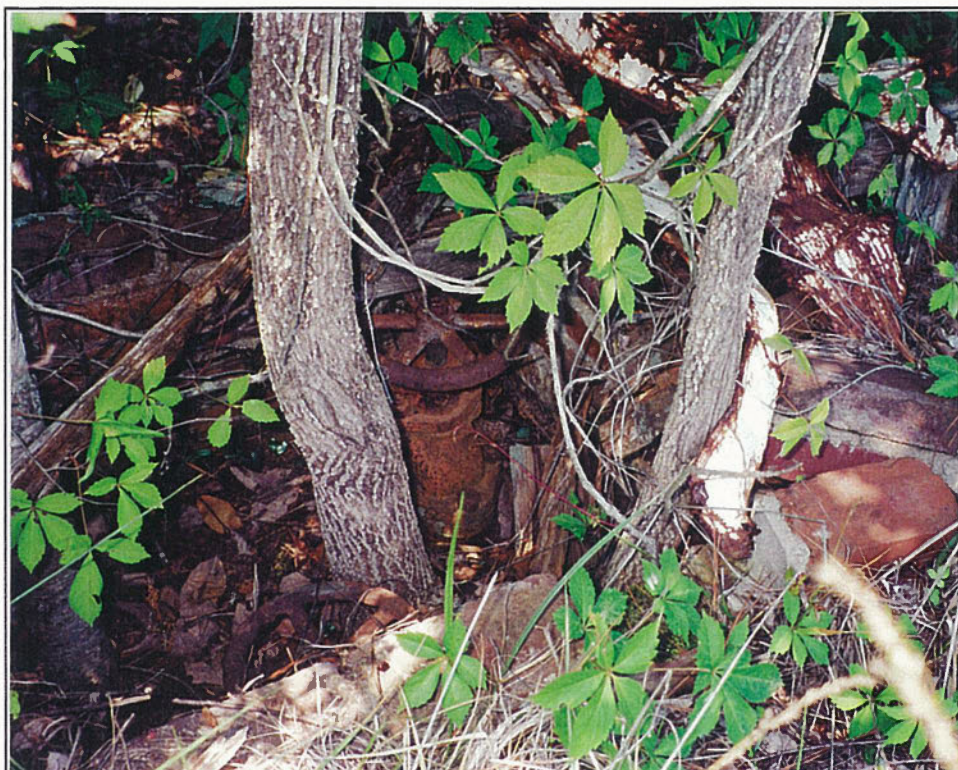
Figure 73. Valve box in the dam village.

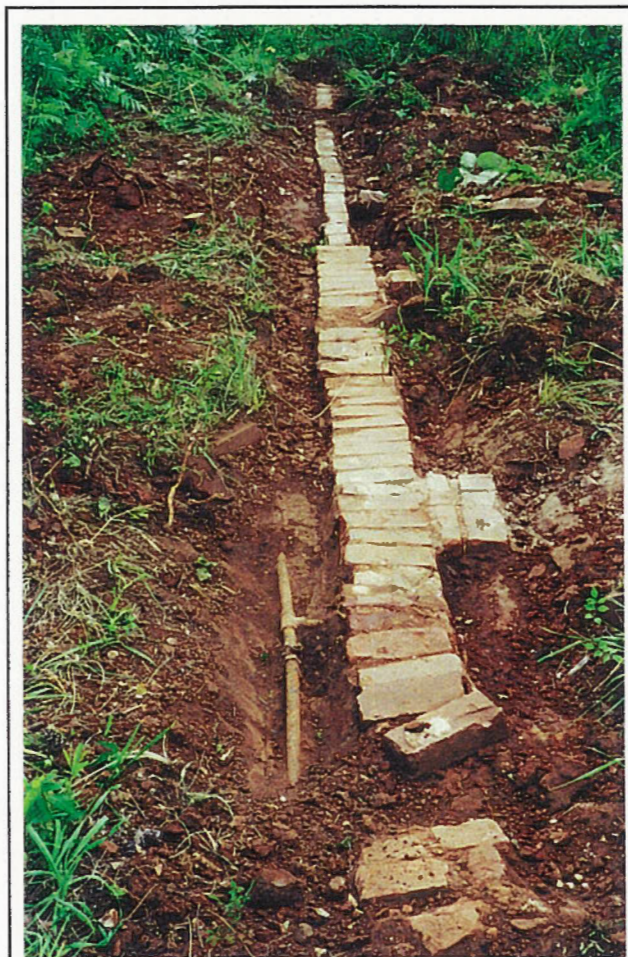
Figure 74. Structure 3 foundation remains at the dam village

While excavating shovel tests, portions of three brick foundations were uncovered. One foundation, possibly of a bunk house, still had a water pipe connected. Other features identified during the shovel testing include additional gravel roads on the site, as well as gravel and brick lined pathways.

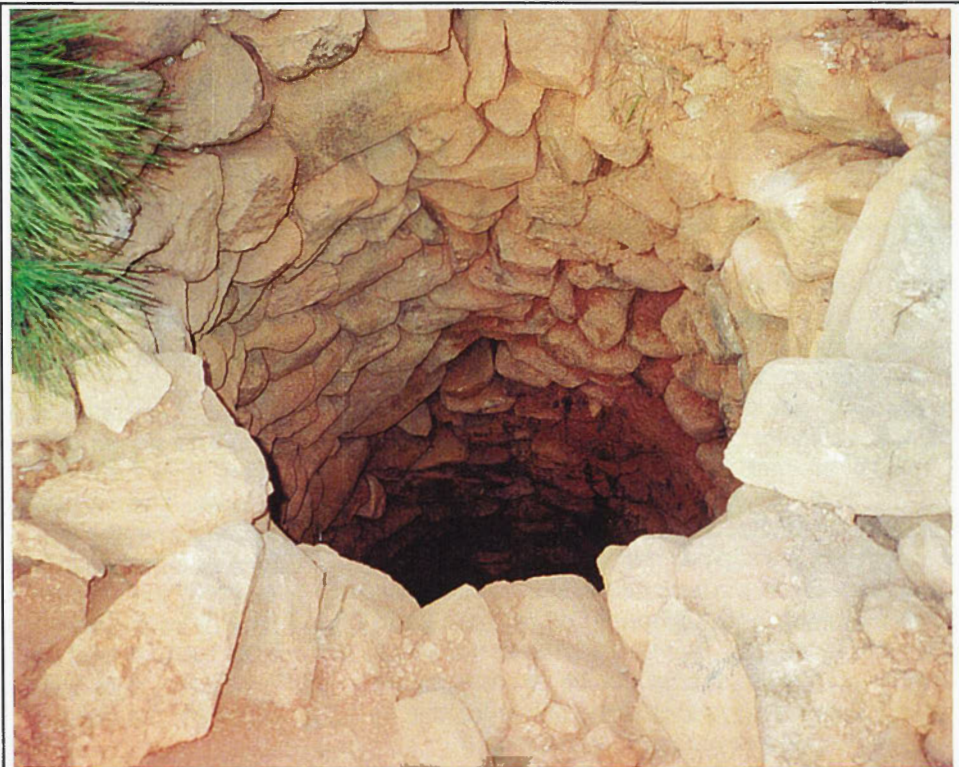
Figure 76. View of well showing construction using dry laid field stones.

Very little is known about the well and since no house or other buildings remain in the area, it is hard to determine who utilized this feature. The well was never abandoned, which is evident from the lack of trash inside. Commonly, when abandoned wells are encountered, trash is found in the bottom from previous owners. The lack of trash may show the swiftness that people may have moved from the property—and this is consistent with what we know of the land use history in the area.

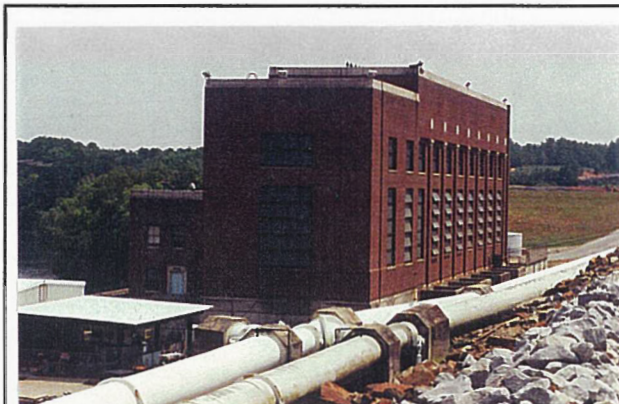
Figure 77. View of the Saluda Hydroelectric Powerhouse (2430127.0) looking southeast.

Of the 11 resources on the survey tract, all but three represent extant components of the Saluda dam, Saluda Hydroelectric facility, or McMeekin plant. Site **2430127.0** is the dam and Saluda Hydroelectric Powerhouse. As previously discussed, the dam was built between September 1927 and September 1930, with the formal completion occurring in December 1930. The powerhouse, of steel, brick, and concrete

construction, measures 250 feet in length, 57 feet in width, and 100 feet high. It contains metal sash projecting windows on the dam (west) facade and a series of five roll-up metal doors on the downstream (east) facade; one at grade and four to allow the transformers to be moved inside the structure for maintenance work. The walls are laid up in 5/1 American bond with concrete medallions and roof parapet. The roof itself consists of a flat concrete deck with membrane roofing. The structure was altered in 1971 by the addition of a fifth turbine at the south end of the structure. The Chief Engineer for the structure was William Spencer Murray, for whom the lake is named and the General Contractor was W.S. Barstow & Company. At the time of construction, the Saluda Dam was the largest earthen dam in the world for power production and the largest artificial power reservoir in the United States. This site also includes the five intake towers in Lake Murray, just beyond the dam and powerhouse.

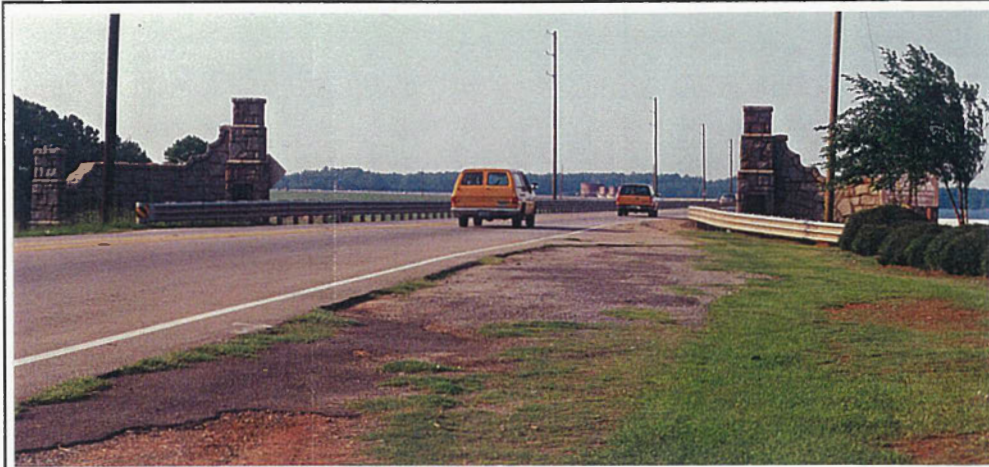
Figure 78. Stone entryway (2430127.02) at the north side of Lake Murray on S.C. 6, view to the south.

Site **2430127.02** represents the entrance gates at both the north and south ends of the dam on SC 6. These are constructed as broken coursed stone walls with bronze plaques. The north pair are readily visible as you cross the dam, while the south pair have been allowed to become overgrown and have almost entirely disappeared into the underbrush. They were erected ca. 1930 by the Highway Commission to commemorate the naming of the lake by a Special Act of the General Assembly. The plaques provide information on the dam, the lake, and the power station.

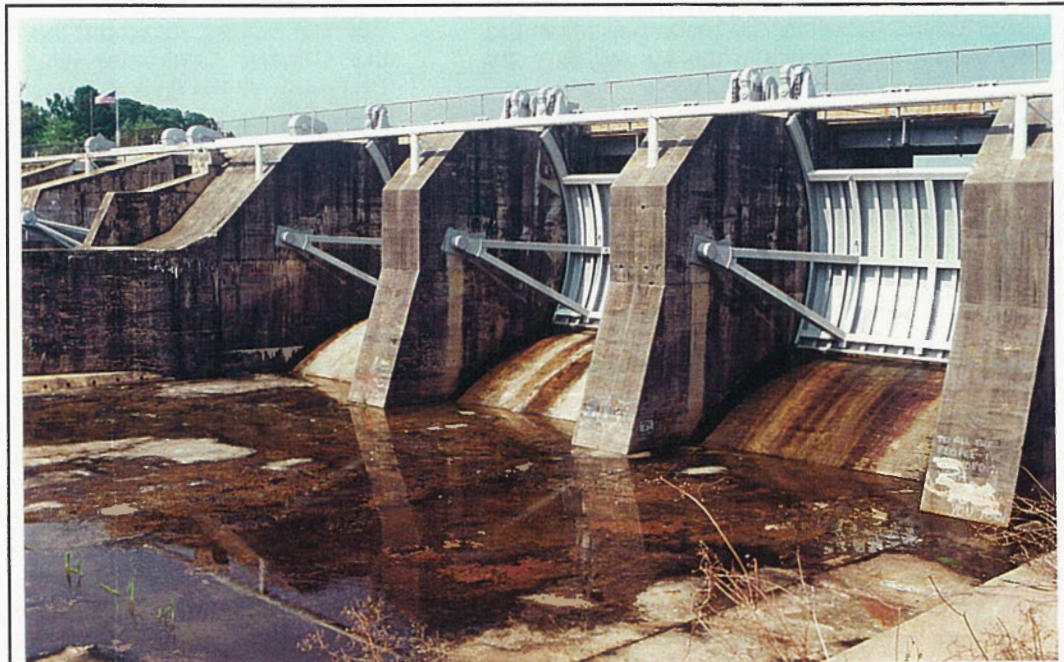
Figure 79. Tainter gates and spillway, site 2430127.03, view to the southwest.

The Spillway and associated gates are represented by **2430127.03**. The initial four gates were constructed as part of the Lake Murray/Saluda Hydroelectric project in 1930 and two additional gates were erected between 1943-1946. Each original gate is 37 feet 6 inches long by 25 feet high and weighs 40 tons.

This site, consisting of the six Tainter gates and concrete spillway, was recommended and found eligible under Criterion A: historic events, Criterion B: important persons, and Criterion C: architecture. Their justification under these criteria is identical to that for resource 2430127.0. It is our understanding that there may

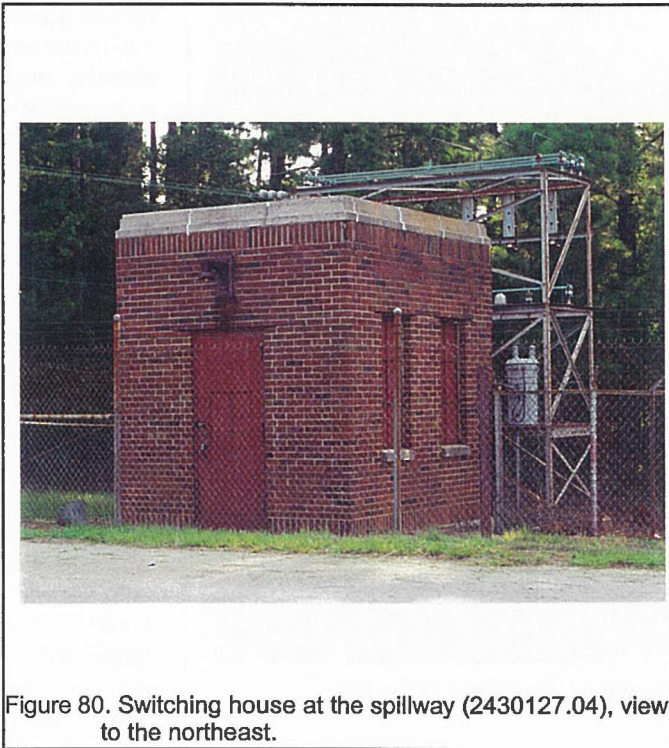
Figure 80. Switching house at the spillway (2430127.04), view to the northeast.

This structure was recommended and found eligible under Criterion C: architecture as representative of the buildings constructed during the 1930s as switching facilities. The fact that this is the last remaining building of this type on the dam complex makes it even more significant. It is our understanding that this structure will not be affected by the proposed undertaking, although it seems susceptible to subsequent, and

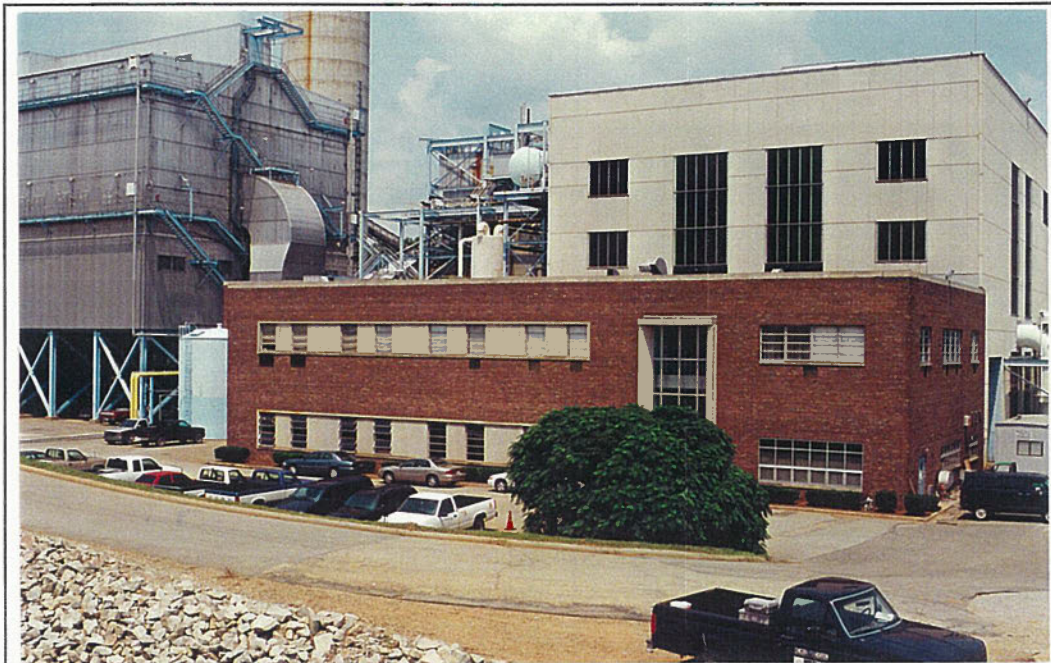
Figure 81. McMeekin Plant (2430127.05), view to the northeast. Baghouse to the left.

Site **2430127.05** is the McMeekin Fossil Fuel Steam Generating Plant, constructed between 1956 and 1958, and altered in ca. 1992 with the addition of Bag Houses 1 and 2 on the north facade. The main building, on a concrete slab foundation, has structural steel framing, corrugated asbestos siding, corrugated glass, aluminum louvers, and a flat roof. An interesting "advancement" for the time was to leave part of the boilers, superheaters, air heaters, and water storage tanks unenclosed outside — reducing ventilating problems. In addition, the use of controlled circulation boilers allowed a significant reduction in the size of the building. Connected to the west facade of the plant itself is a two-story brick building that contains offices, locker rooms, labs, storerooms, and meeting rooms. The brick and concrete construction of the west facade is not only typical of the 1950s, but also picks up similar elements in the Saluda Hydroelectric Plant and serves to tie the two facilities together. The bag houses were added as a means to remove particulates and reduce air pollution.

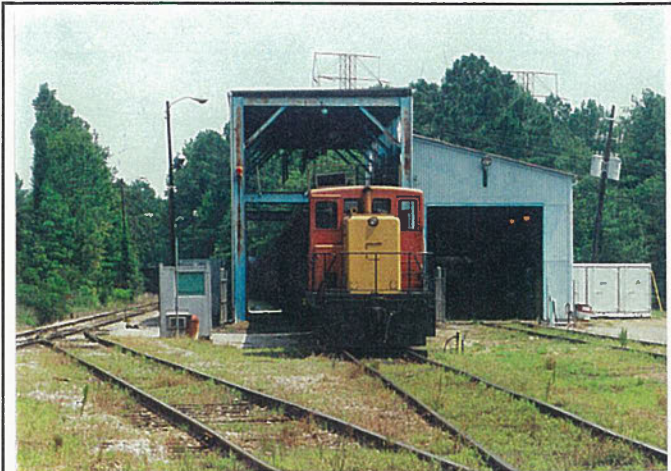
Figure 82. McMeekin Track Hopper House (2430127.06), view to the south.

Like the McMeekin plant, this structure is less than 50 years old. However, we believe that it will likely be eligible as a part of the entire McMeekin facility when it achieves sufficient age. As with the previous structure, this facility was found not eligible by the State Historic Preservation Office due to age, but may be considered eligible in 2008 provided that it is not considerably altered. We do not believe that it will be affected by the proposed undertaking.

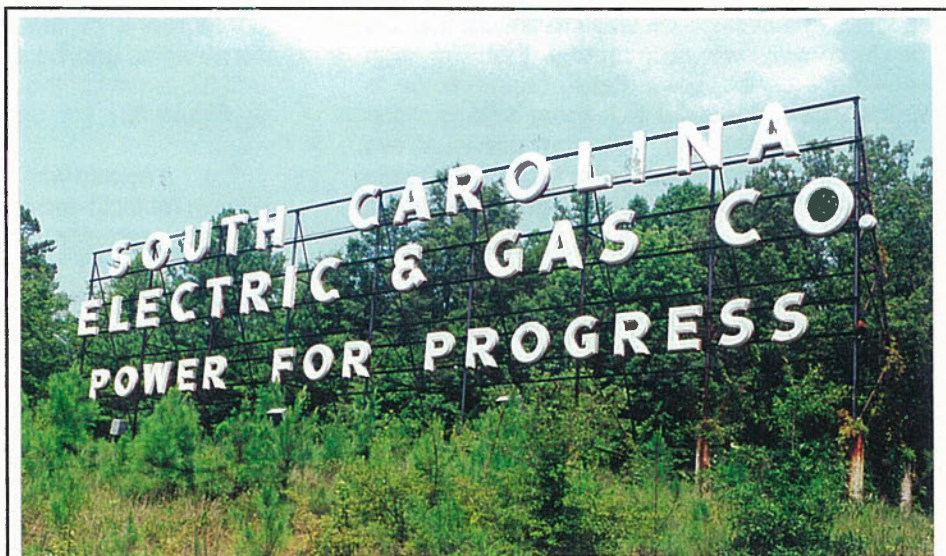
Figure 83. "Power for Progress" sign (2430127.07), view to the north-northwest.

Site 2430127.07 is a large sign situated on the ridge slope north of the McMeekin facility. Consisting of internally illuminated plastic letters, when operating it spelled out "Power for Progress." We have been unable to identify much information about this sign, although it appears to have been erected ca. 1958 — about the time that the McMeekin plant was completed. It represents what might be called corporate boosterism and was very typical of the period when utilities were dramatically increasing production and encouraging consumers to do the same, usually with very cheap electric rates. It is was during this period that American industries, and the public, believed that not only was this cheap power inexhaustible, but that its use was clear and convincing proof of progress. This theme is echoed in the SCE&G corporate history, which includes the chapters, "Program for Progress" and

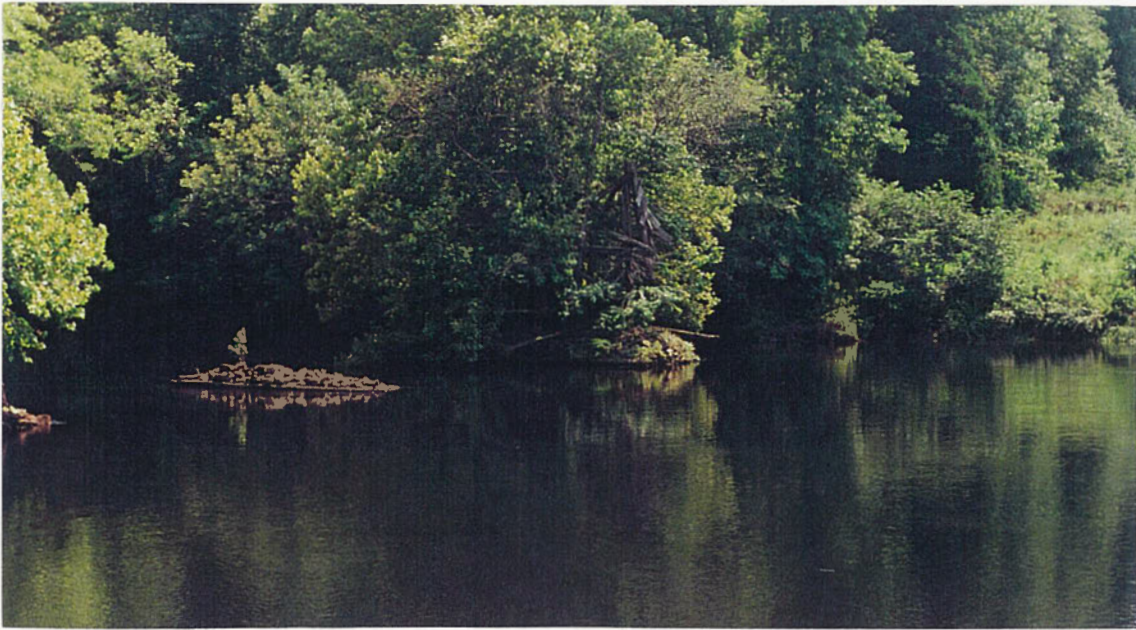
Figure 84. Remnant caissons for the temporary bridge across the Saluda River (2430128), view to the southwest.

This site was recommended and found not eligible for inclusion on the National Register since so little remains intact. The remains, while interesting and clearly identifiable, no longer possess the integrity necessary for eligibility.
